**Environment Representative (ER) Monthly Report for October 2024**

**Project: SSD-17647189 – Access Logistics Park, 884-928 Mamre Rd, Kemps Creek**

## Environmental Representative Monthly Report for October 2024 (ERMR\_08)

### Project SSD-17647189 – Access Logistics Park, 884-928 Mamre Rd, Kemps Creek

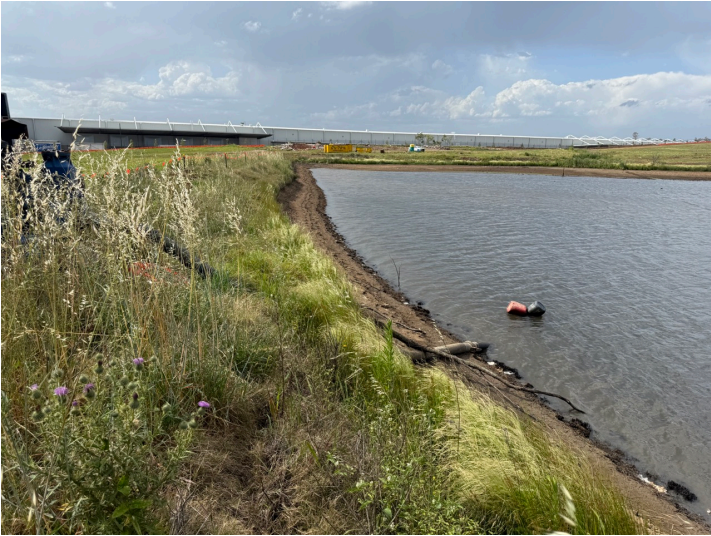
<b>Photo 04</b>	<b>Dam A dewatering</b>
		28/10/2024	The pump collection hose within Dam A continues to be monitored. Additional lengths of hose are to be added as required to prevent the inlet point being on the dam wall / bed.

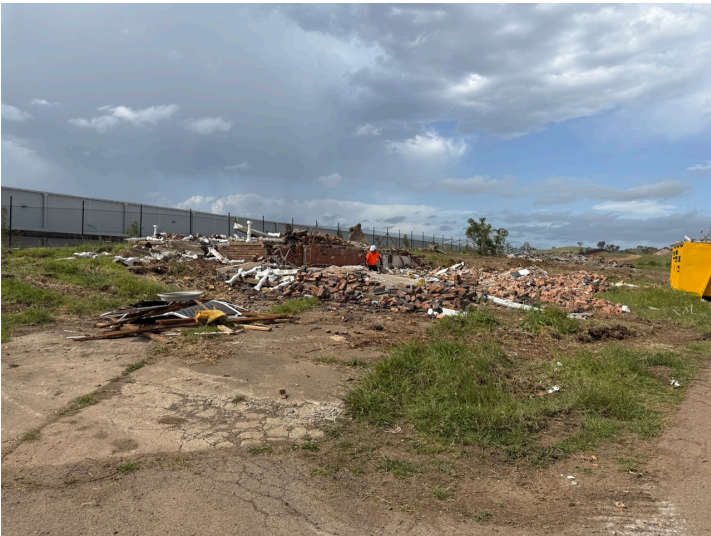
<b>Photo 05</b>	<b>Structure demolition</b>
		28/10/2024	Following hazardous materials assessment, and asbestos removal as required, including the issue of a clearance certificate, site structures have been demolished. Construction and demolition waste has been segregated on site, prior to collection and disposal / reuse at a licensed waste facility.
