**Re: Environment Representative (ER) Monthly Report for February 2025**  
**Project: SSD-17647189 – Access Logistics Park, 884-928 Mamre Rd, Kemps Creek**

## Environmental Representative Monthly Report for February 2025 (ERMR\_12)

### Project SSD-17647189 – Access Logistics Park, 884-928 Mamre Rd, Kemps Creek

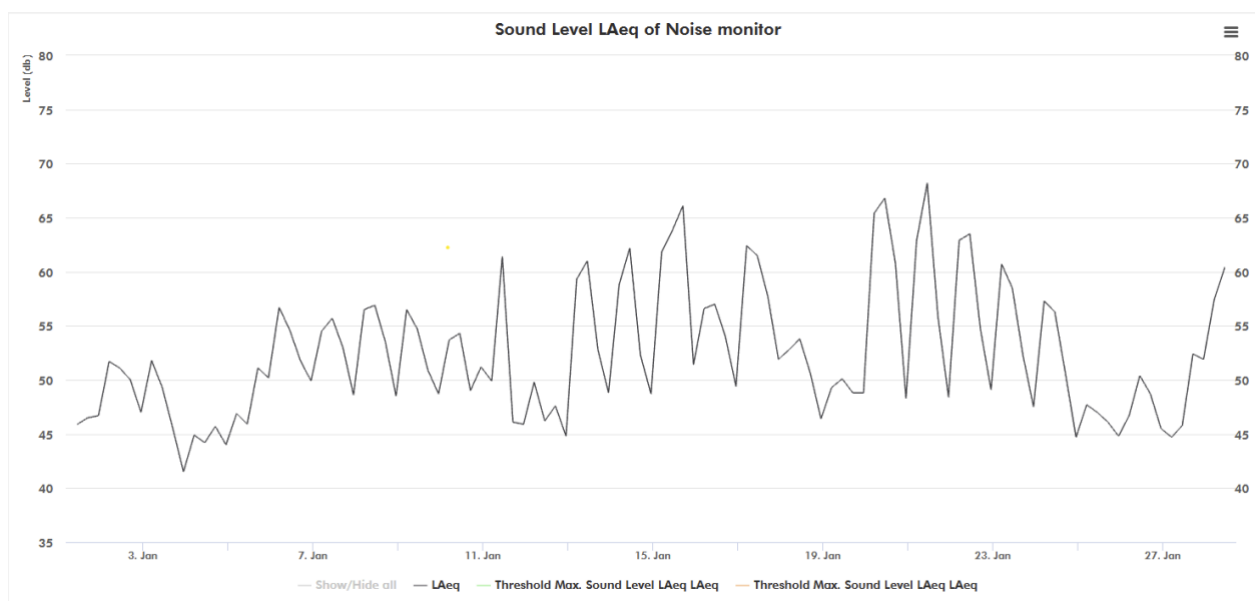
**Realtime noise monitoring results:** Noise levels measured during the reporting period are presented in the graph below, taken from a location on the southern site boundary nearest to the sensitive receiver (930 Mamre Road).

Results indicate noise levels consistent with those predicted in the Construction Noise and Vibration Management Plan (CNVMP) for both the demolition modelled scenario and the bulk earthworks modelled scenario (refer to Table 17 of the CNVMP). The maximum noise level (LAeq) recorded was 74dBA during earthworks at the beginning of the reporting period, and 82dBA at the end of the reporting period during demolition works. These results are compared to a predicted noise level (with no mitigation measures implemented – i.e. noise barrier) of 74 dBA for earthworks and 82 dBA for demolition works. A summary of the real-time noise level data is presented in the screenshot below.

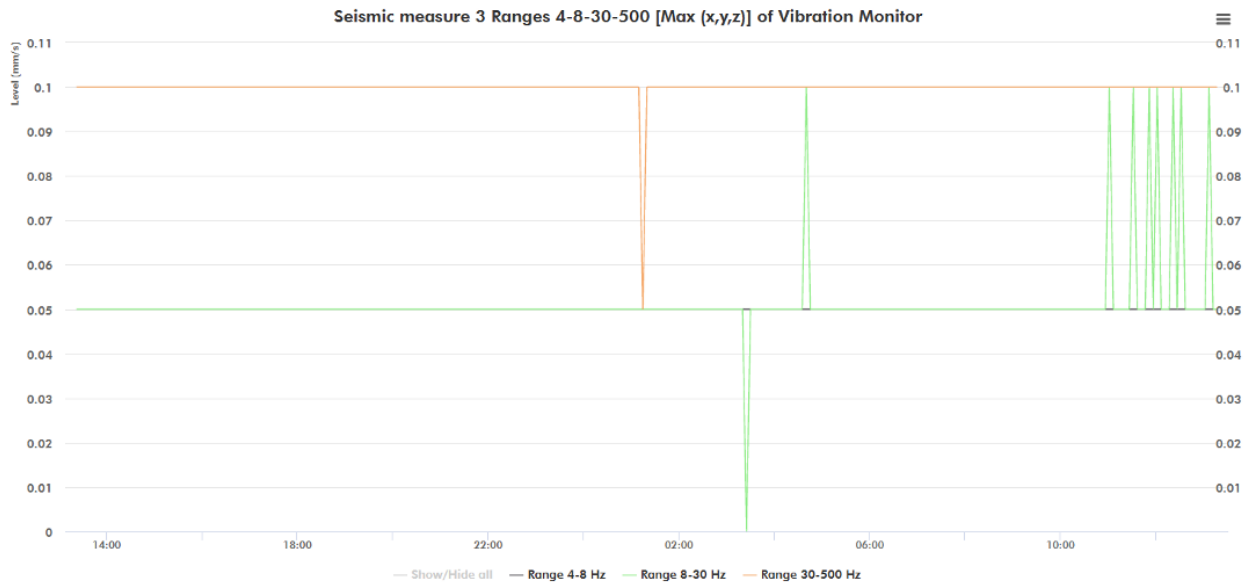
**Vibration monitoring results:** Realtime vibration monitoring results for the reporting period are presented in the graph below.

Vibration levels measured at the site boundary of the nearest sensitive receiver (930 Mamre Road) indicate levels well below the vibration thresholds as detailed in the CNVMP (15mm/s at 4Hz, 20mm/s at 15 Hz and 50mm/s at 40 Hz and above).

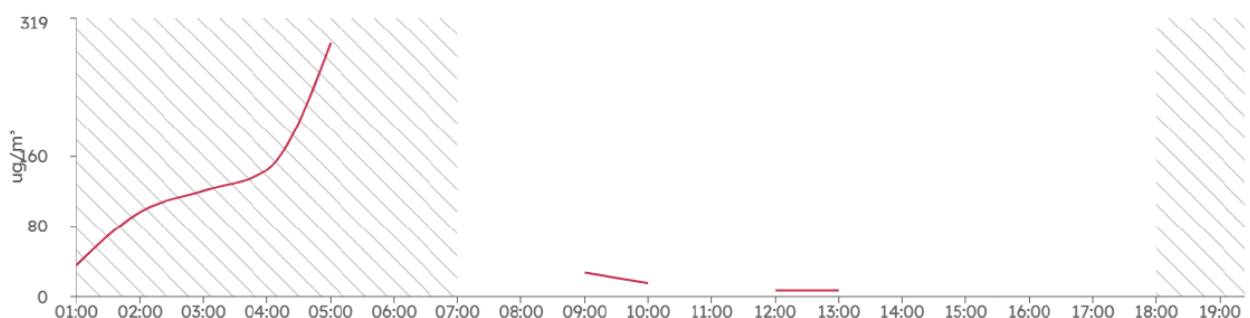
#### Particulate Matter Mass Concentrations | PM10

Available real-time air quality monitoring results for the month of February 2025 are shown below, showing three (3) events where the daily annual average PM10 criteria of 50 $\mu\text{g}/\text{m}^3$  was exceeded.

- 07/02/2025 (South): Minor exceedances attributed to high humidity levels overnight and at the start at the day, during times of no site activity. A copy of the real-time PM10 graph was sighted for the 24-hour period which correlates with Burton's advice.
- 07/02/2025 (East): Minor exceedances attributed to high humidity levels overnight and at the start at the day, during times of no site activity. A copy of the real-time PM10 graph was sighted for the 24-hour period which correlates with Burton's advice.
- 12/02/2025 (East): Exceedance attributed to a fault with the monitor during this period resulting only partial readings throughout the 24 period, distorting / misrepresenting the 24-hour average. A copy of the real-time PM10 graph was sighted for the 24-hour period which correlates with Burton's advice. See screen shot below.

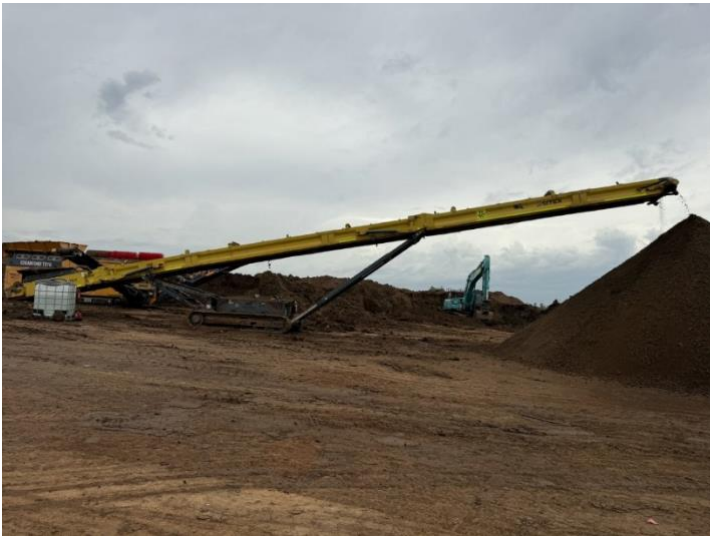
<b>Photo 04</b> 14/02/2025	<b>Topsoil processing</b> <p>Burtions' sub-contractor continues to process topsoil using a trommel screen and load-out conveyors.</p> <p>Environmental controls remain in place including:</p> <ul style="list-style-type: none"><li>• A dedicated water cart specifically for the topsoil processing area</li><li>• Fixed water sprays on the arms of the load-out conveyors</li><li>• Shade-cloth screening along the northern boundary</li><li>• Ongoing use of real-time air quality monitoring around the site perimeter.</li></ul>

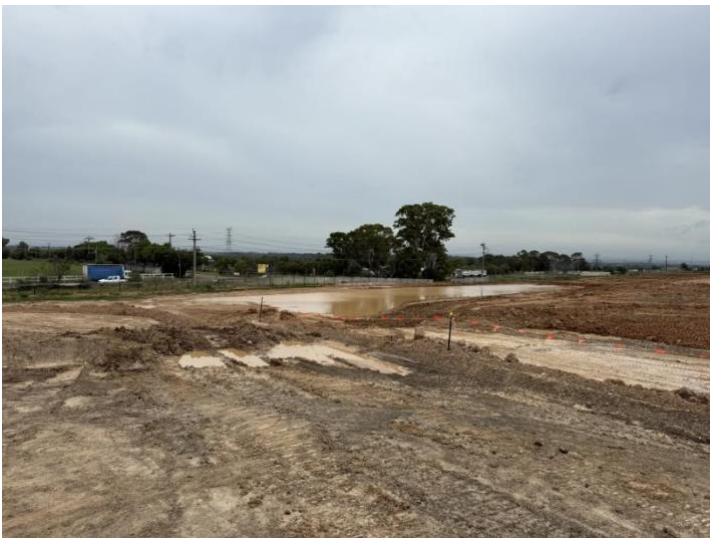
<b>Photo 05</b> 14/02/2025	<b>High efficiency sediment basin</b> <p>Despite the recent rainfall event, the HES Basin water level still remains very low, noting that Burtions advised they treated and emptied the basin just prior to the rainfall event.</p> <p>The water quality still appears to contain a high sediment load, although Burtions advised they have recently been pumping direct to the large basin, bypassing the forebay / treatment zone, given the poor treatment results achieved to date using this method. Water treatment using a spray polymer is to be applied prior to discharge, ensuring discharge water quality is achieved.</p>
