Barings – Access Estate

BURTONS Contractors

Erosion and Sediment Inspection Report
 Inspection Date: 01 November 2024

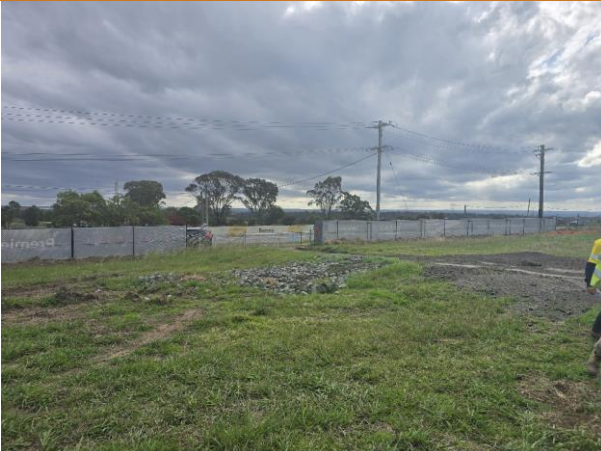
Action (Observation / Recommendation)	Photo	Timeframe (L,M,H,I)	Responsibility	Close out Comment
<p>REC-003</p> <p>Recommendation</p> <p>The former access to the property forms a channel and has potential for site water to exit uncontrolled. Implement a berm control to ensure water is retained on site.</p>

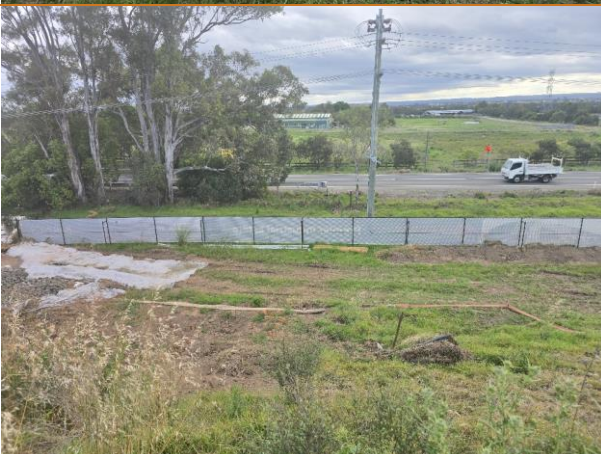
L	M. Ak	It is noted this action was completed during the inspection.
<p>REC-004</p> <p>Recommendation</p> <p>The end of the berm along the road frontage for Mamre Road has potential for dirty water to mix with the clean water leaving the site. A separation berm to retain site water should be implemented. Based on the retention of the groundcover, the berm would be required to hold approx. 748m3 of runoff to accommodate the 95% basin design requirement.</p>

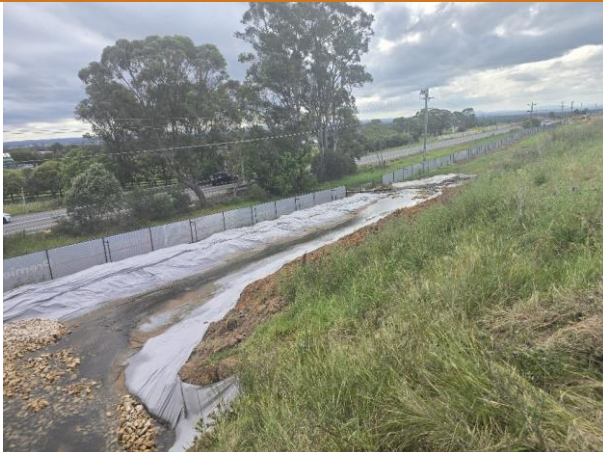
Action (Observation / Recommendation)	Photo	Timeframe (L,M,H,I)	Responsibility	Close out Comment
REC-005 Recommendation The clean water drain has a section of exposed material on the batter which may result in sedimentation of the watercourse. Implement a strip of geofabric to cover the exposed material and retain clean water passage.

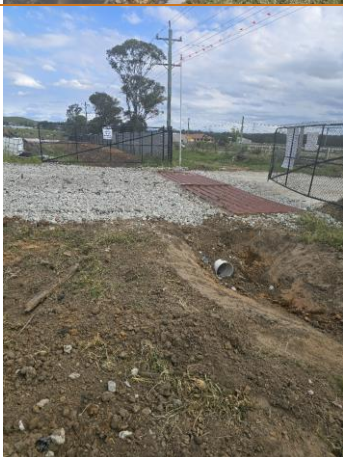
L	M. Ak	
REC-005 Recommendation The pipe under the access road is not installed as per the ESCP which calls for a larger diameter pipe. A second pipe is recommended to achieve the required flow rate. a. The approximate flow of the twin 300mm pipes would be 320L/S or 0.32m3/sec. The required flow rate as designed for the basin 2 in the southwestern portion of the site is 0.268m3/sec. Therefore the twin 300mm pipes would be deemed adequate.

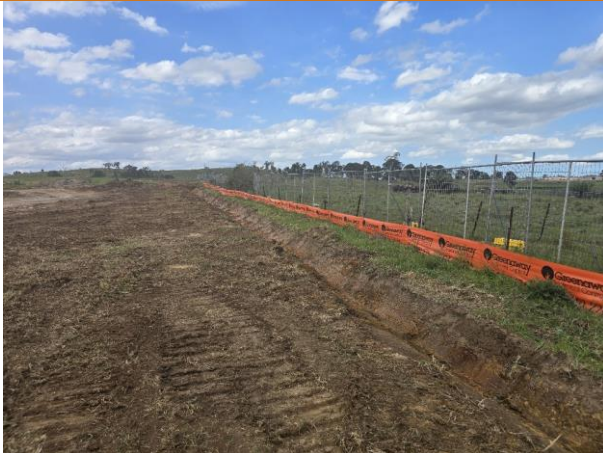
Action (Observation / Recommendation)	Photo	Timeframe (L,M,H,I)	Responsibility	Close out Comment
OB-001 Observation The southern boundary swale drain is installed for on site water management. Water in the drain is directed to the basin.

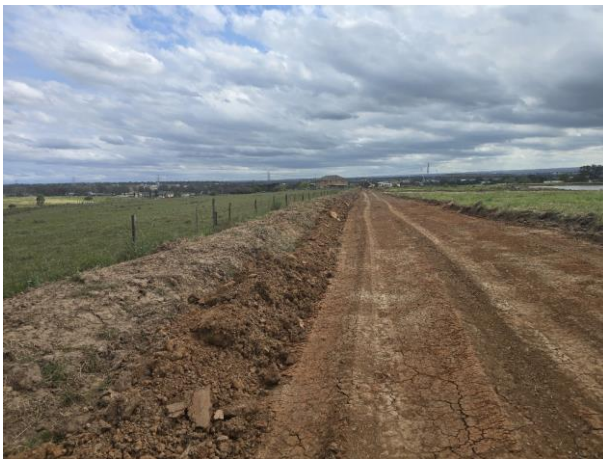
OB-002 Observation The southern boundary implements a diversion berm where landform has water potentially entering the site. The berm is installed well and has utilized topsoil to allow for vegetation growth as protective cover.

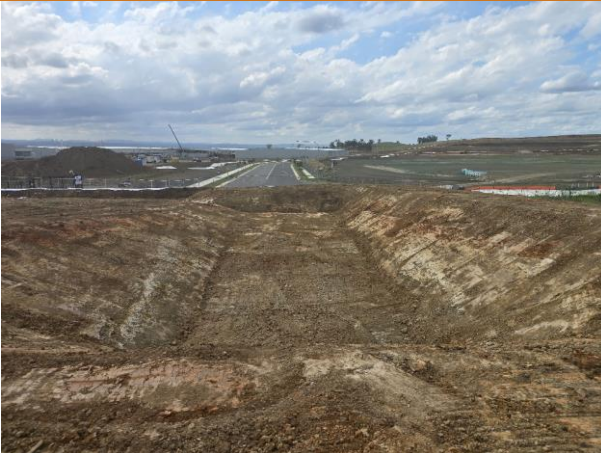
Action (Observation / Recommendation)	Photo	Timeframe (L,M,H,I)	Responsibility	Close out Comment
<p>OB-003</p> <p>Observation</p> <p>A sump has been constructed on Lot 11 where elevations direct overland flow to the north east. The sump is proposed to accommodate the 5-day 85% catchment calculation for the 3.11ha catchment for Lot 11 until elevation changes as part of the earthworks stage allow for the catchment to be directed to the approved AB2 basin.</p>

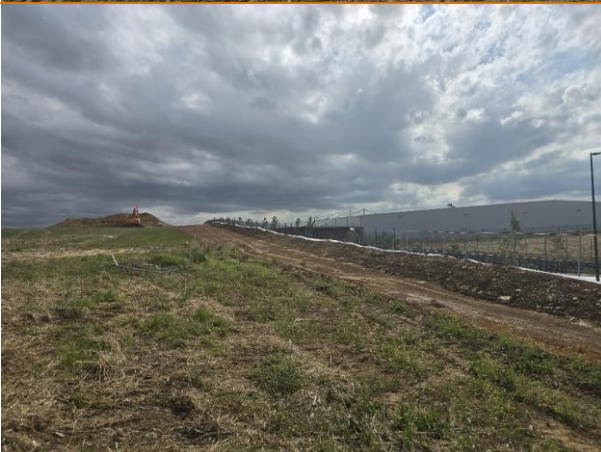
N/A		
<p>OB-004</p> <p>Observation</p> <p>A berm has been implemented along the northern boundary to contain site water. The external batter is protected by fabric to limit sediment runoff from the berm.</p>

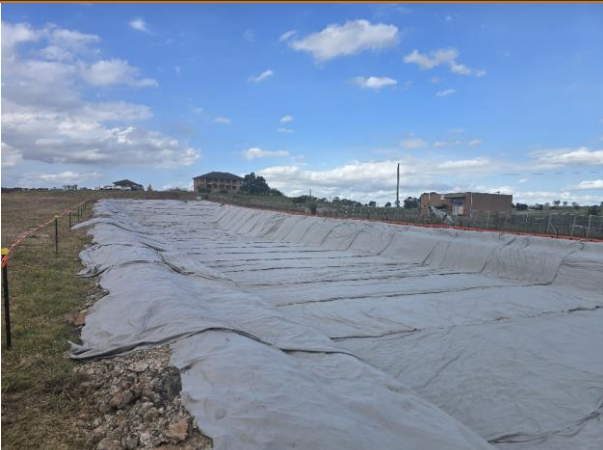
Action (Observation / Recommendation)	Photo	Timeframe (L,M,H,I)	Responsibility	Close out Comment
OB-007 Observation Basin AB2 is installed as per the design and will be used to manage water on the site for the Lot 2 earthworks.
