Barings – Access Estate

BURTONS Contractors

Erosion and Sediment Inspection Report
 Inspection Date: 03 March 2025

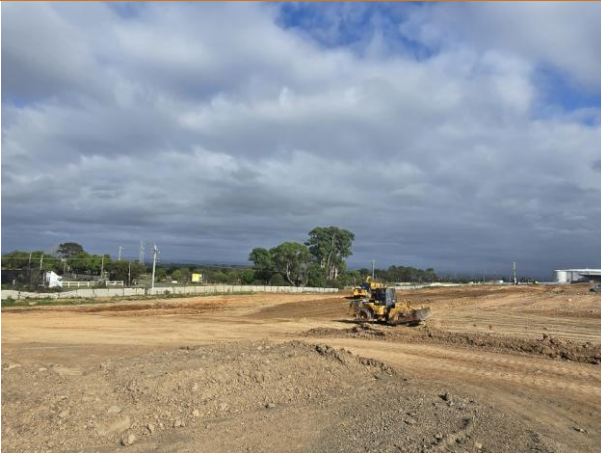
| Action (Observation / Recommendation) | Photo | Timeframe (L,M,H,I) | Responsibility | Close out Comment |
|--|---|---|---|---|
| OB-003 Observation Earthworks for Lot 2 are progressing with elevations approaching final landform design levels. | | N/A | | |

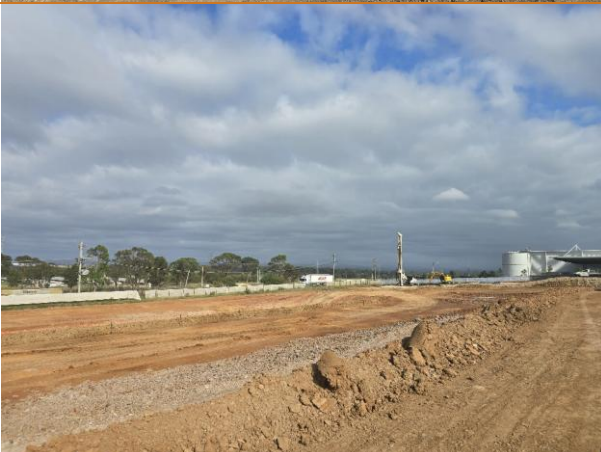
| Action (Observation / Recommendation) | Photo | Timeframe (L,M,H,I) | Responsibility | Close out Comment |
|--|---|---|---|---|
| OB-004 Observation The site has established a series of internal berm controls to direct water to the treatment basin locations and to limit impacts to the fill / placement areas . | | N/A | | |
