Barings – Access Estate

BURTONS Contractors

Erosion and Sediment Inspection Report
 Inspection Date: 14 February 2025

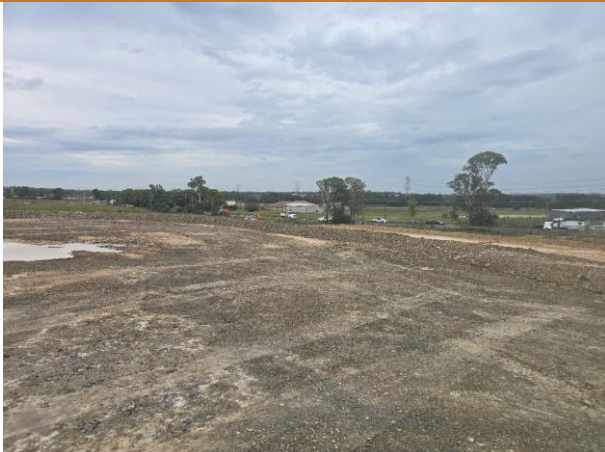
Action (Observation / Recommendation)	Photo	Timeframe (L,M,H,I)	Responsibility	Close out Comment
OB-001 Observation Earthen berms are implemented around active work areas and fill zones to segment the site catchment areas.

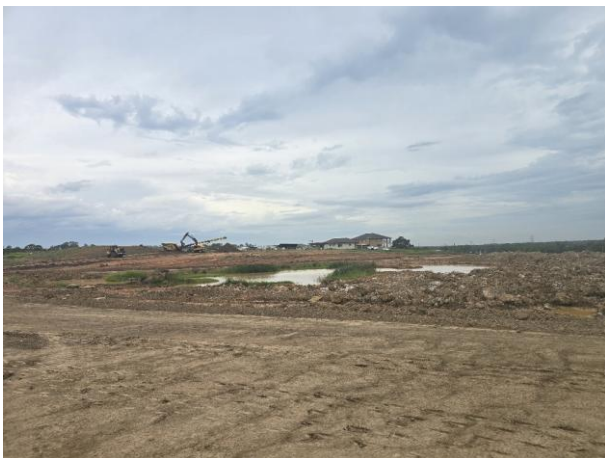
N/A		
OB-002 Observation Internal depressions are used for additional water retention on site and to manage extreme events without overloading the basins.

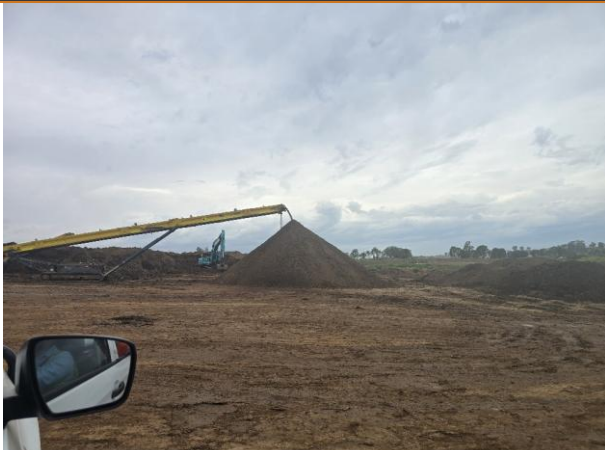
Action (Observation / Recommendation)	Photo	Timeframe (L,M,H,I)	Responsibility	Close out Comment
OB-004 Observation Topsoil processing is being undertaken in the north western portion of the site.
