## Barings – Access Estate

### BURTONS Contractors

Erosion and Sediment Inspection Report  
 Inspection Date: 18 December 2024

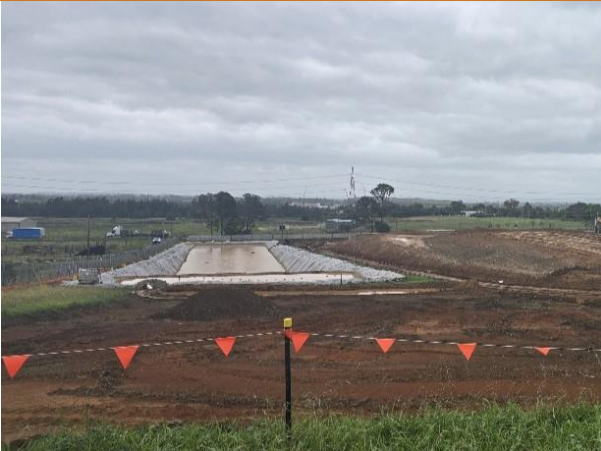
Action (Observation / Recommendation)	Photo	Timeframe (L,M,H,I)	Responsibility	Close out Comment
<p>REC-003</p> <p>Recommendation</p> <p>The BA2 basin is holding water that is discolored as a result of transfer pumping.</p> <p>It is noted that this water is being used on site for construction and suppression activities.</p> <p>Remaining water should be passed through the treatment unit for flocculation prior to the shut down period.</p>

L	M.A	<p>Ongoing - Water level reduced significantly and poses no risk of overflow.</p> <p>Dewatering to continue after the break.</p> <p>Additionally, automated pump has been installed at adjacent sump</p>
<p>OB-001</p> <p>Observation</p> <p>The Lot 2 area elevation has increased to allow water to be drained to the basin inlet. This reduces the dependence on the sump and pump arrangement.</p>

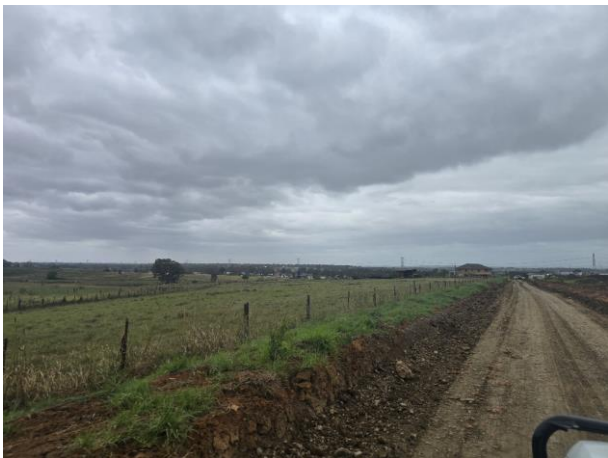
Action (Observation / Recommendation)	Photo	Timeframe (L,M,H,I)	Responsibility	Close out Comment
OB-002 Observation The external / boundary berms have vegetated and are stable.

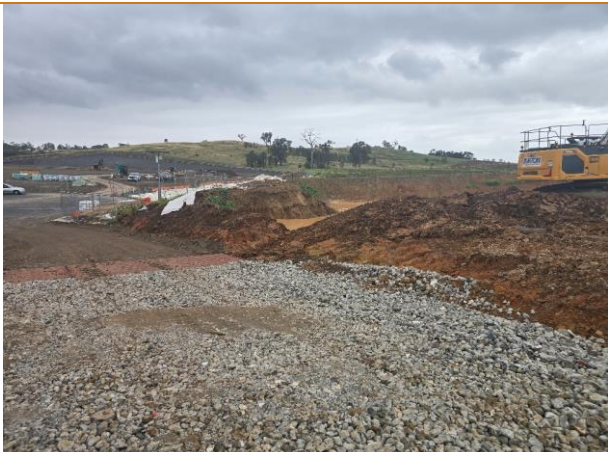
N/A		
OB-003 Observation The new access is constructed with the adjacent basin being completed. This is to be completed prior to the shut down period.

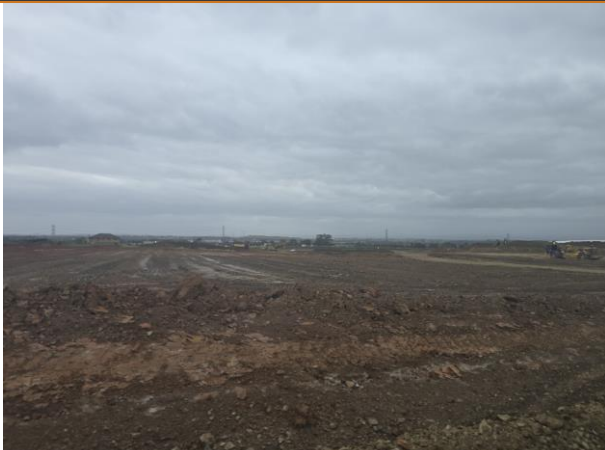
Action (Observation / Recommendation)	Photo	Timeframe (L,M,H,I)	Responsibility	Close out Comment
OB-004 Observation The central area is being used for fill material for Lot 2. The area is surrounded by berm controls an has limited potential for runoff. Water from the area is managed through Basin AB2
