# Barings – Access Estate

## BURTONS Contractors

Erosion and Sediment Inspection Report  
 Inspection Date: 23 January 2025

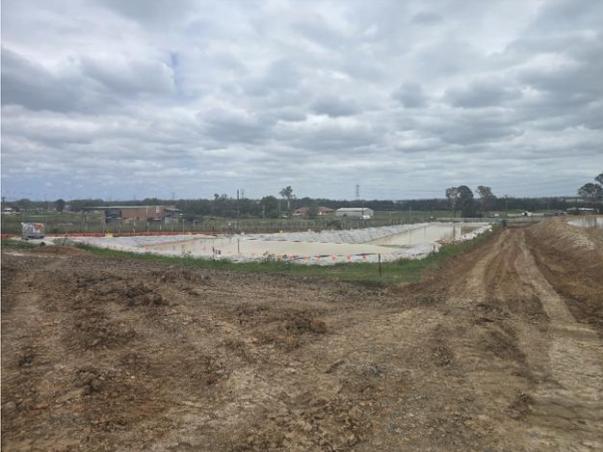
| Action<br>(Observation / Recommendation) | Photo | Timeframe<br>(L,M,H,I) | Responsibility | Close out Comment |
|---|---|---|---|---|
| <p>REC-001</p> <p>Recommendation</p> <p>Water in Basin AB2 appears discolored in the main bay which his likely due to pumping rate from detention areas on site and ineffective treatment. Water should be recycled through the treatment unit or flocked to reduce sediment load.</p> | | L | | |

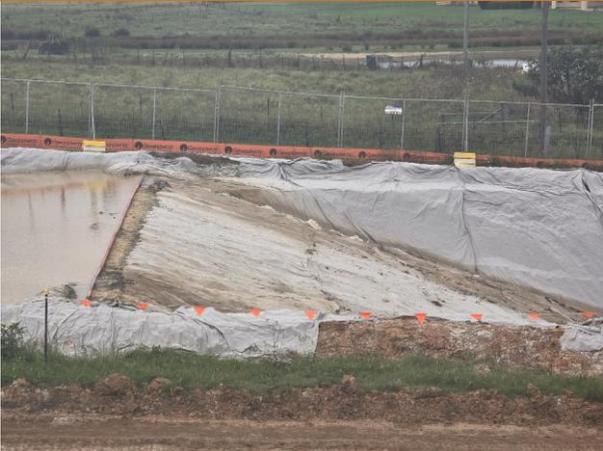
| Action<br>(Observation / Recommendation) | Photo | Timeframe<br>(L,M,H,I) | Responsibility | Close out Comment |
|---|---|---|---|---|
| <p>REC-002</p> <p>Recommendation</p> <p>The southern end of the weir wall has a low point where water is concentrating and scouring the wall. This should be blocked (i.e. sandbag) to engage the full width of the weir and improve treatment.</p> | | L | | |

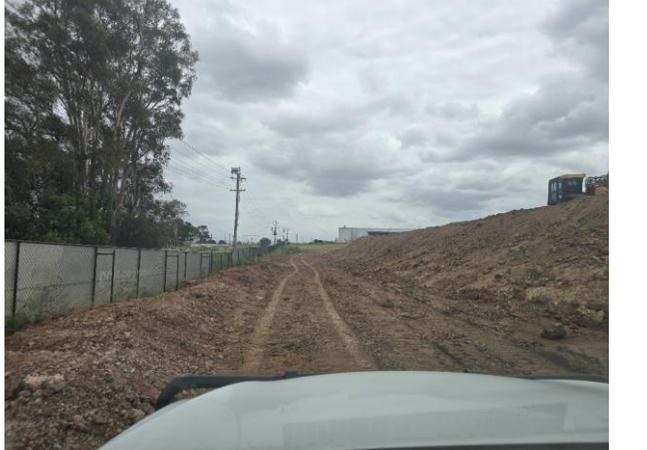
| Action<br>(Observation / Recommendation) | Photo | Timeframe<br>(L,M,H,I) | Responsibility | Close out Comment |
|---|---|---|---|---|
| <p>OB-001<br/>Observation<br/>The former dam dewatering location has been removed with the bund wall extended the length of the site frontage to Mamre Road.</p> | | N/A | | |

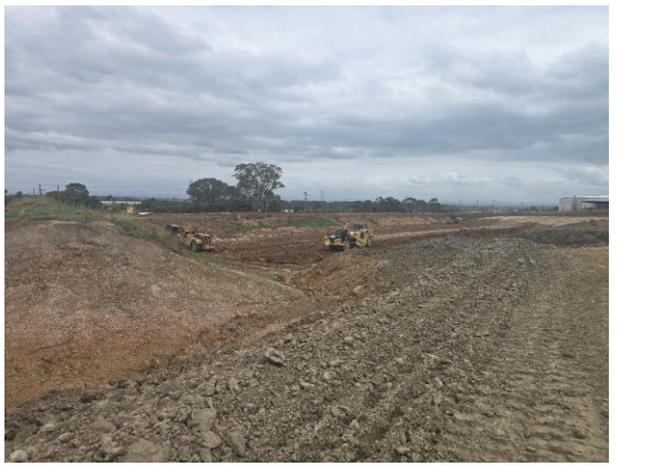
| Action<br>(Observation / Recommendation) | Photo | Timeframe<br>(L,M,H,I) | Responsibility | Close out Comment |
|---|---|---|---|---|
| <p>OB-002<br/>Observation<br/>Fill placement is being undertaken in the Lot 2 development area following the decommissioning of the former dam.</p> | | N/A | | |

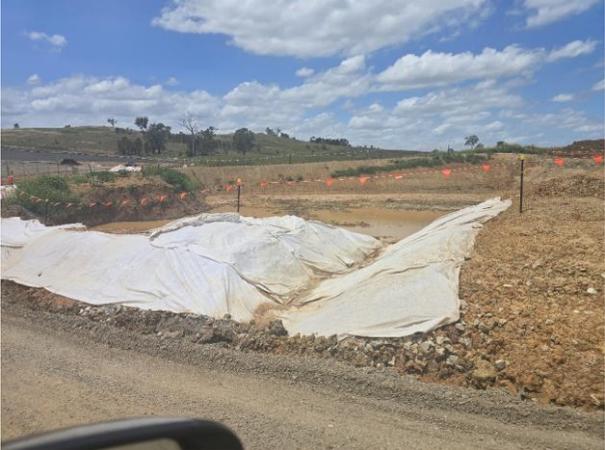
| Action<br>(Observation / Recommendation) | Photo | Timeframe<br>(L,M,H,I) | Responsibility | Close out Comment |
|---|---|---|---|---|
| OB-003<br>Observation<br>The new access is constructed with the adjacent basin being completed. | | N/A | | |
