Barings – Access Estate

BURTONS Contractors

Erosion and Sediment Inspection Report
 Inspection Date: 26 November 2024

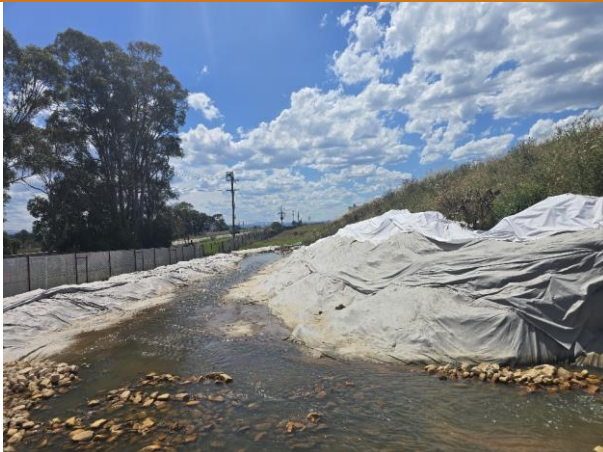
Action (Observation / Recommendation)	Photo	Timeframe (L,M,H,I)	Responsibility	Close out Comment
OB-003 Observation Discharge from the dam is being undertaken through the lined channel. Water is discharging at a low rate and is visibly clear. .

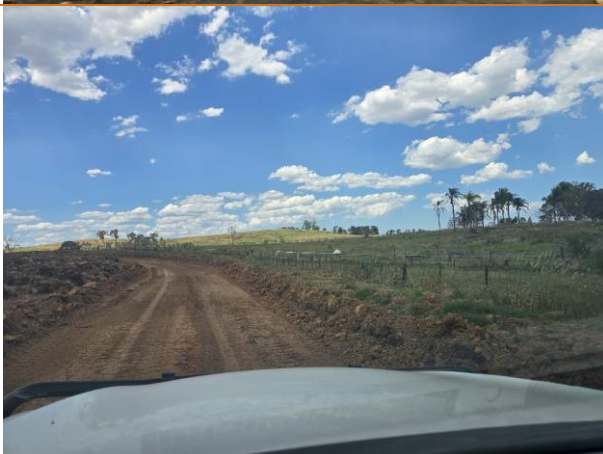
N/A		
OB-004 Observation The berms installed along the boundary areas are starting to vegetate from the natural seed bank providing additional protection from scour and sedimentation.

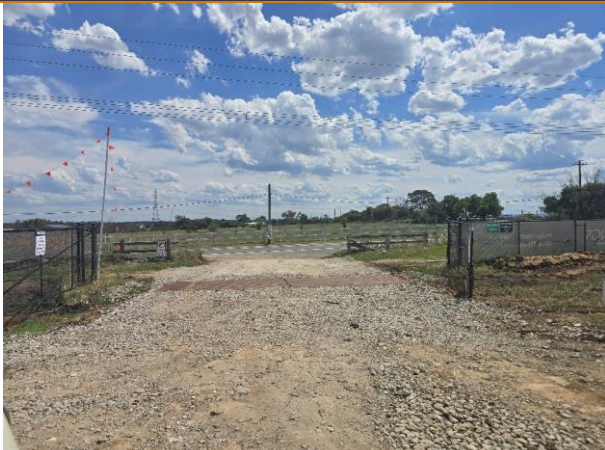
Action (Observation / Recommendation)	Photo	Timeframe (L,M,H,I)	Responsibility	Close out Comment
OB-005 Observation The access area is stable and has implemented a shaker grid. No signs of tracking material was identified.
