Re: Environment Representative (ER) Monthly Report for May 2025
Project: SSD-17647189 – Access Logistics Park, 884-928 Mamre Rd, Kemps Creek

Environmental Representative Monthly Report for May 2025 (ERMR_15)

Project SSD-17647189 – Access Logistics Park, 884-928 Mamre Rd, Kemps Creek

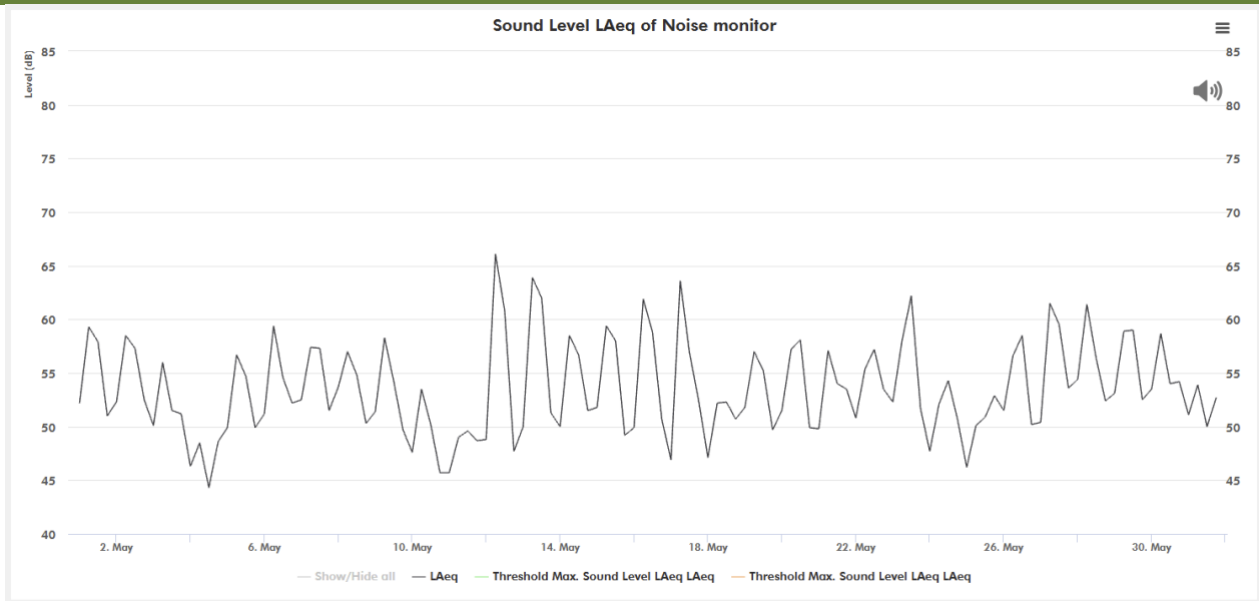
12	Review of monitoring results by ER	<p><u>Realtime noise monitoring results:</u> Noise levels measured during the reporting period are presented in the graph below, taken from a location on the southern site boundary nearest to the sensitive receiver (930 Mamre Road).</p> <p>Results indicate noise levels consistent with those predicted in the Construction Noise and Vibration Management Plan (CNVMP) for both the bulk earthworks modelled scenario (refer to Table 17 of the CNVMP). The maximum noise level (LAeq) recorded was 66dBA during earthworks compared to a predicted noise level (with no mitigation measures implemented – i.e. noise barrier) of 74 dBA.</p> <p>A summary of the real-time noise level data is presented in the screenshot below.</p>

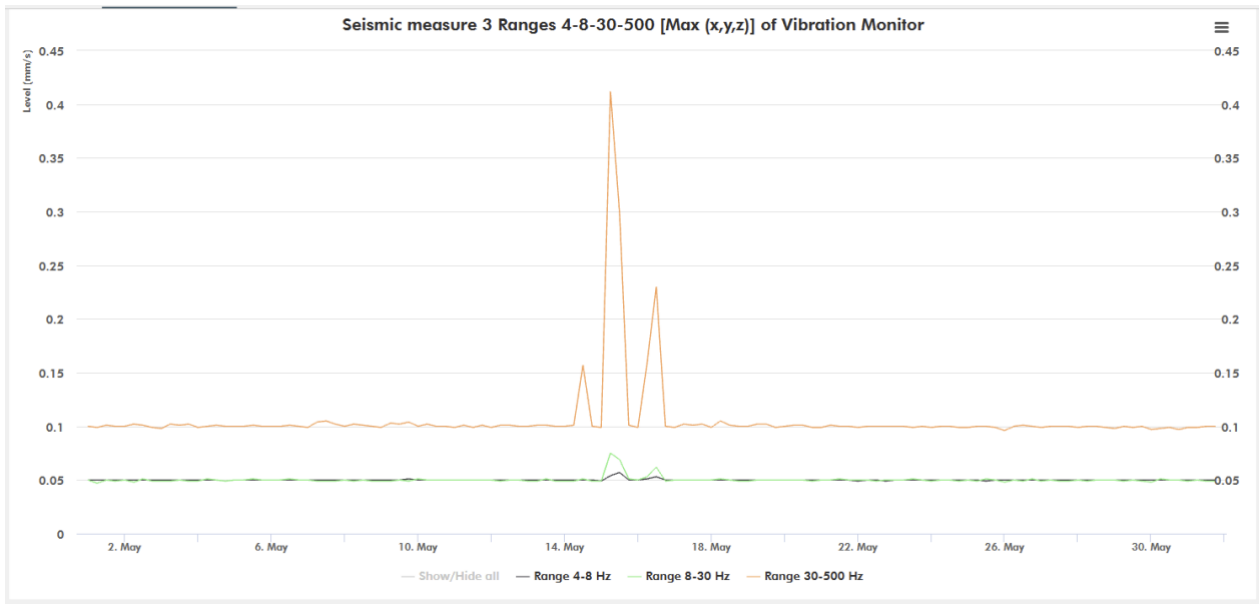
Vibration monitoring results: Realtime vibration monitoring results for the reporting period are presented in the screenshot below.

Vibration levels measured at the site boundary of the nearest sensitive receiver (930 Mamre Road) indicate levels well below the vibration thresholds as detailed in the CNVMP (15mm/s at 4Hz, 20mm/s at 15 Hz and 50mm/s at 40 Hz and above).
