Re: Environment Representative (ER) Monthly Report for June 2025
Project: SSD-17647189 – Access Logistics Park, 884-928 Mamre Rd, Kemps Creek

Environmental Representative Monthly Report for June 2025 (ERMR_16)

Project SSD-17647189 – Access Logistics Park, 884-928 Mamre Rd, Kemps Creek

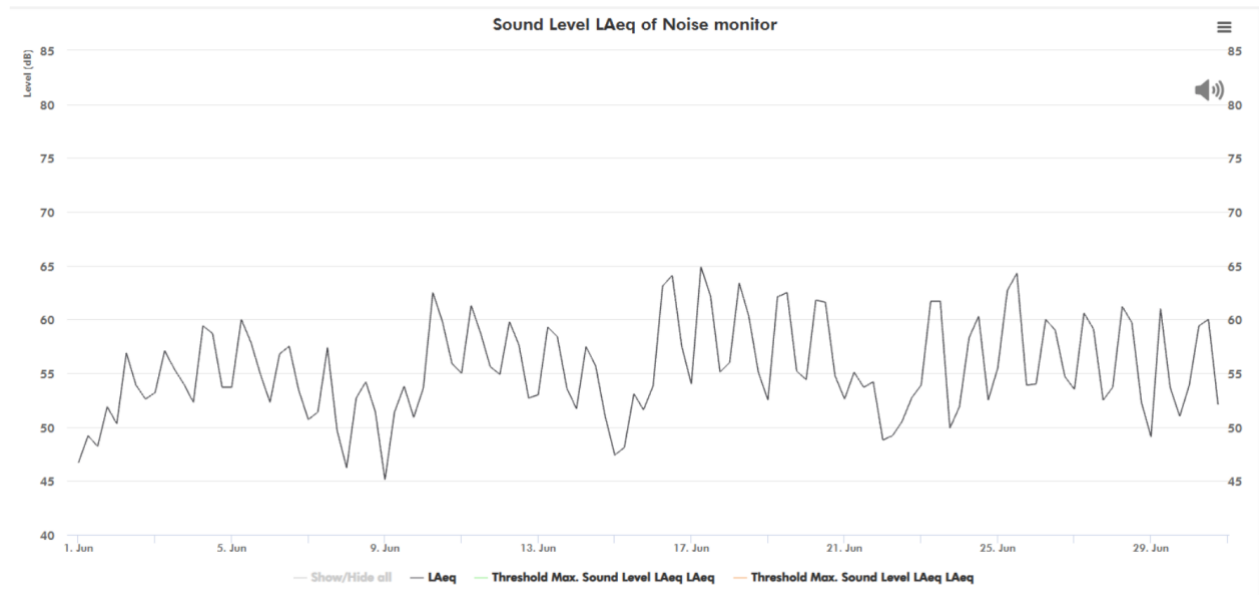
Realtime noise monitoring results: Noise levels measured during the reporting period are presented in the graph below, taken from a location on the southern site boundary nearest to the sensitive receiver (930 Mamre Road).

Results indicate noise levels consistent with those predicted in the Construction Noise and Vibration Management Plan (CNVMP) for both the bulk earthworks modelled scenario (refer to Table 17 of the CNVMP). The maximum noise level (LAeq) recorded was 65dBA during earthworks compared to a predicted noise level (with no mitigation measures implemented – i.e. noise barrier) of 74 dBA.

A summary of the real-time noise level data is presented in the screenshot below.

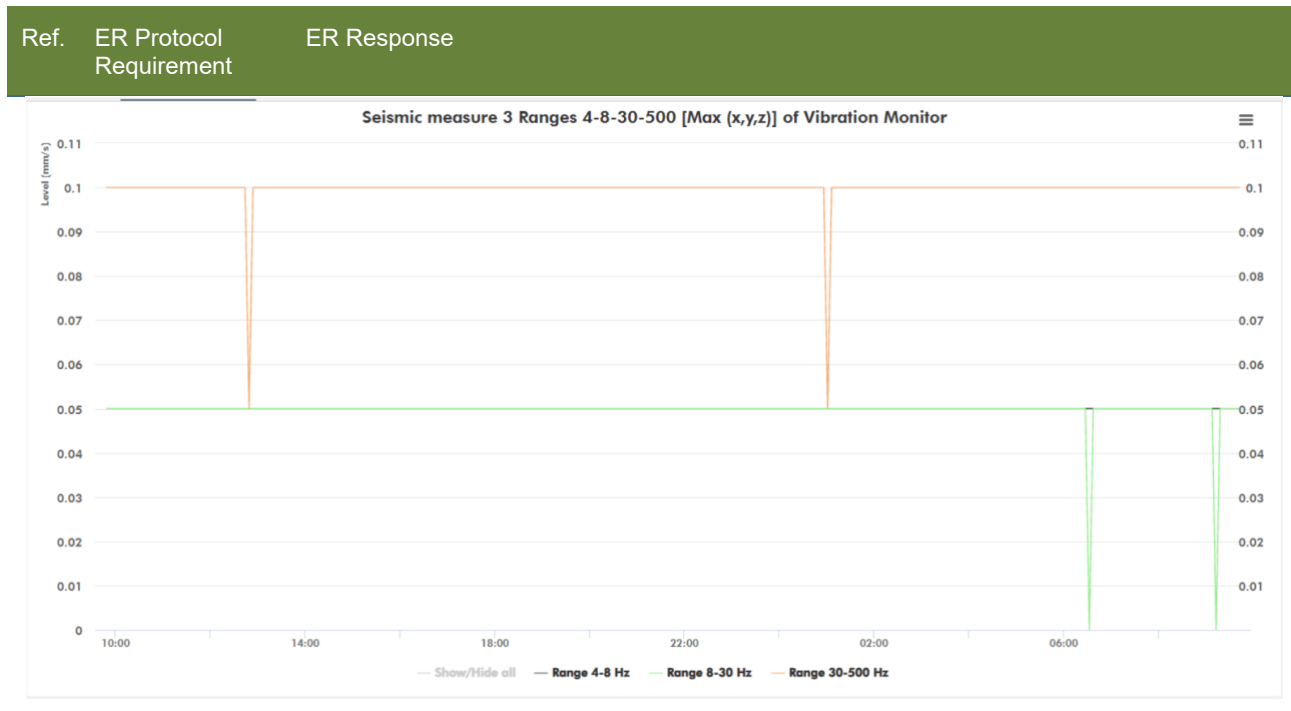
Vibration monitoring results: Realtime vibration monitoring results for the reporting period are presented in the screenshot below.

Vibration levels measured at the site boundary of the nearest sensitive receiver (930 Mamre Road) indicate levels well below the vibration thresholds as detailed in the CNVMP (15mm/s at 4Hz, 20mm/s at 15 Hz and 50mm/s at 40 Hz and above).
