**Re: Environment Representative (ER) Monthly Report for July 2025**  
**Project: SSD-17647189 – Access Logistics Park, 884-928 Mamre Rd, Kemps Creek**

## Environmental Representative Monthly Report for July 2025 (ERMR\_17)

### Project SSD-17647189 – Access Logistics Park, 884-928 Mamre Rd, Kemps Creek

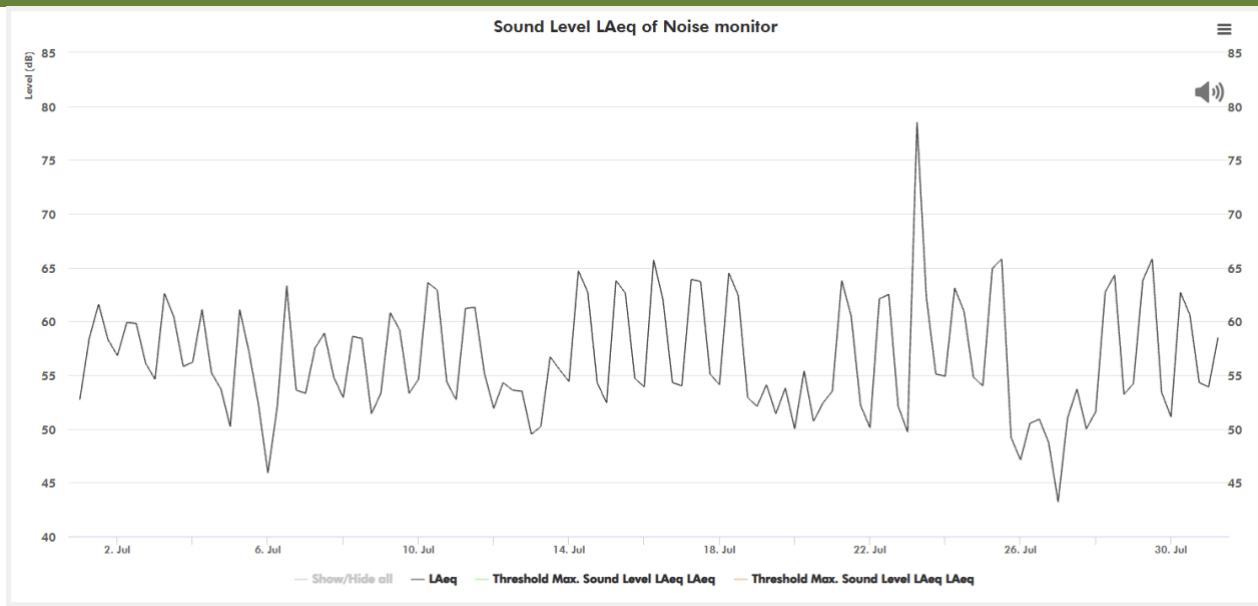
12	Review of monitoring results by ER	<p><b>Realtime noise monitoring results:</b> Noise levels measured during the reporting period are presented in the graph below, taken from a location on the southern site boundary nearest to the sensitive receiver (930 Mamre Road).</p> <p>Results indicate noise levels consistent with those predicted in the Construction Noise and Vibration Management Plan (CNVMP) for both the bulk earthworks modelled scenario (refer to Table 17 of the CNVMP). The maximum noise level (LAeq) recorded was approximately 79dBA during earthworks compared to a predicted noise level (with no mitigation measures implemented – i.e. noise barrier) of 74 dBA. The exceedance of predicted noise levels was attributed to short-term concrete saw-cutting activities for the construction of the stormwater pipework within the south-western portion of the site.</p> <p>A summary of the real-time noise level data is presented in the screenshot below.</p>

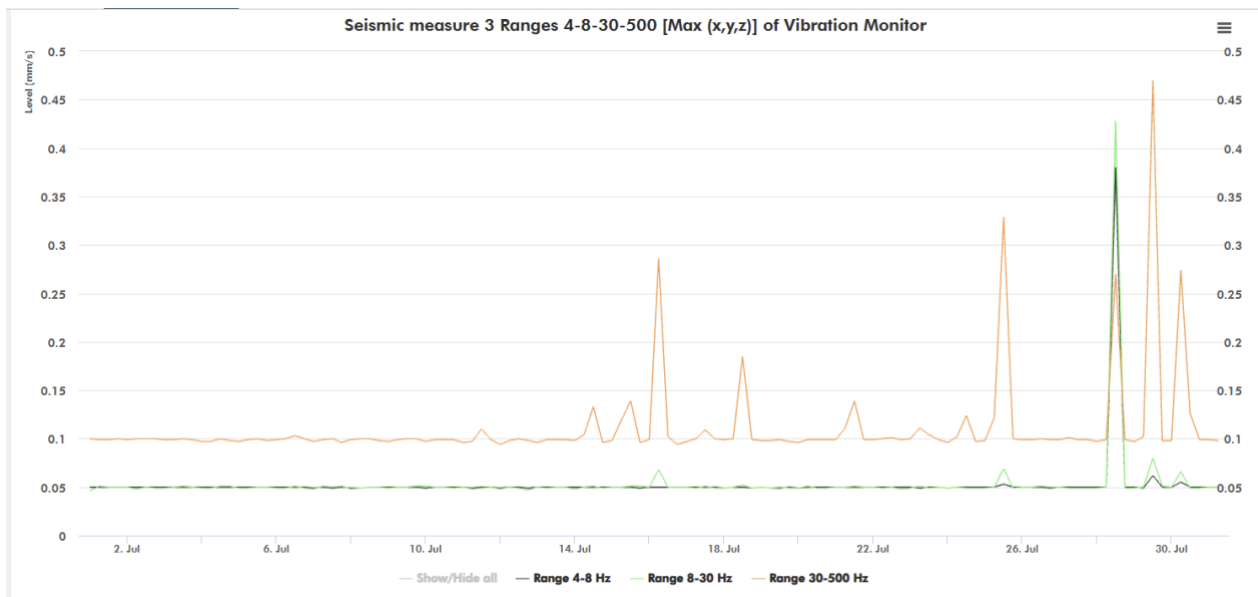
**Vibration monitoring results:** Realtime vibration monitoring results for the reporting period are presented in the screenshot below.

Vibration levels measured at the site boundary of the nearest sensitive receiver (930 Mamre Road) indicate levels well below the vibration thresholds as detailed in the CNVMP (15mm/s at 4Hz, 20mm/s at 15 Hz and 50mm/s at 40 Hz and above).

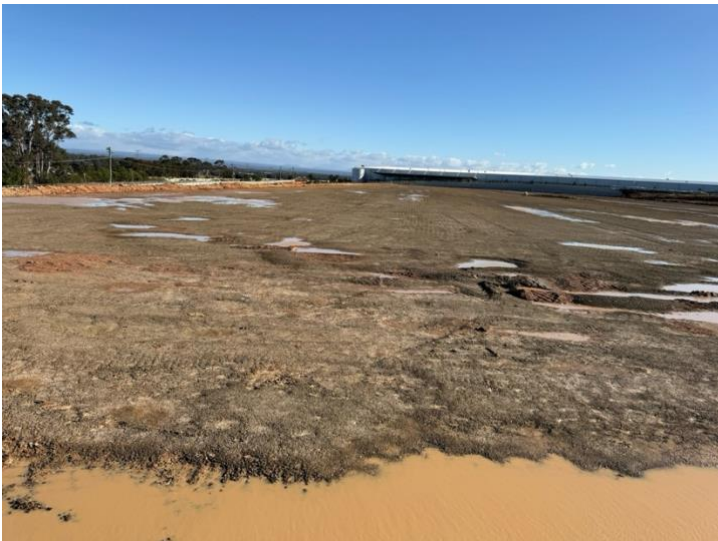
<b>Photo 01</b> 10/07/2025	<b>Lot 2 Pad Completion</b> <p>Lot 2 profiling was complete prior to the rainfall event received late June / early July. The rain prevented Lot 2 from being completed – still requiring minor scraping and proof rolling – this is expected to be completed over the coming week, providing suitable moisture levels are achieved.</p> <p>Once proof rolling is complete, the lot can be handed over to the warehouse construction contractor.</p>	
	<b>Photo 02</b> 10/07/2025	<b>Bioretention basin – Northwestern corner</b> <p>Surface water runoff from the previous rainfall event continues to be batched through various areas of the site, before being either direct discharged or sent to the site HES Basin. The excavation at the base of the 2B retaining wall (along the northern boundary) was being used for the storage and treatment water – the difference between treated and untreated can be seen in the photo to the right. Once suitable water quality is achieved (test results sighted at the time of the inspection), the water is discharged from site in accordance with the site basin discharge protocol.</p>
